# Conservation Policy of Visual Quality in Connecting Area Between Historical Areas

Garudea<sup>1</sup>, Bambang Soemardiono<sup>1</sup>, and Didit Novianto<sup>1</sup>

<sup>1</sup>Architecture Department, Institut Teknologi Sepuluh Nopember, Surabaya, Indonesia

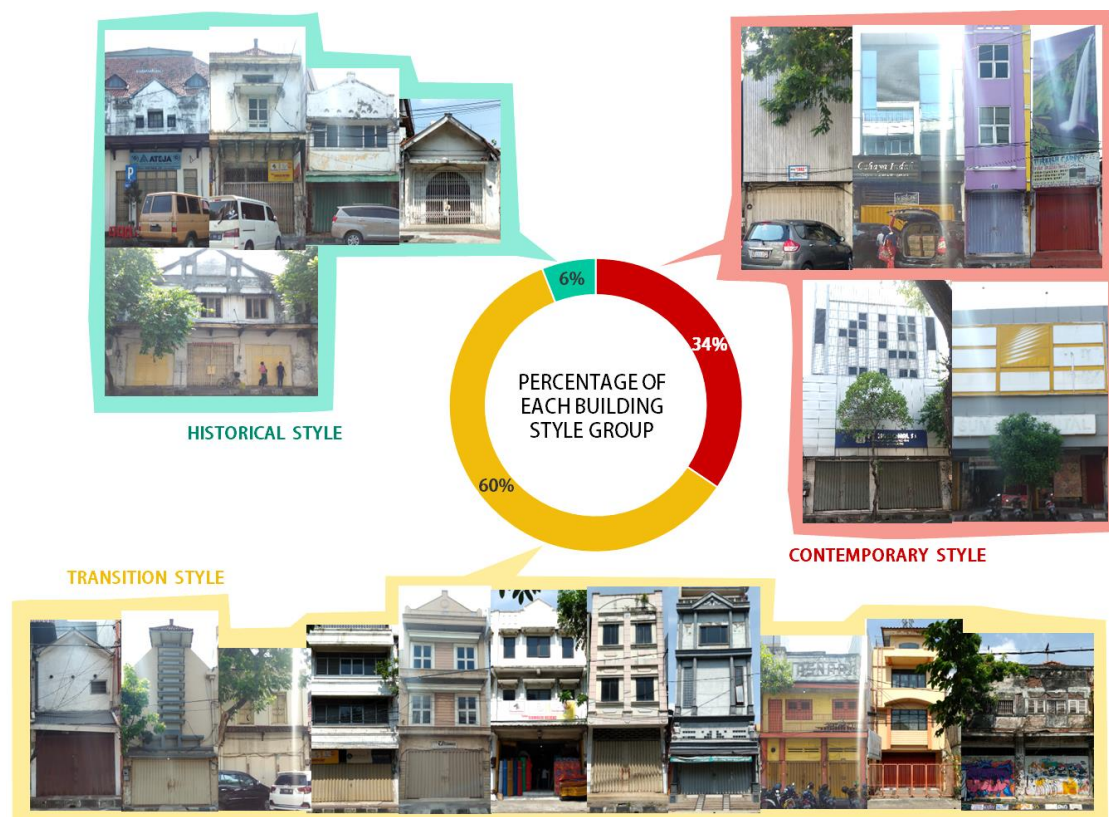
Figure 2. Groups of Building Styles  
Authors' Analysis

Based on the assessment result in Figure 2, 3 groups of building styles were obtained. The contemporary-style building group consists of 52 buildings (34%). The transitional-style building group consists of 92 buildings (60%). This group of buildings will be divided into two sub-groups, namely the transitional sub-group, which tends to be historical in style, and the transitional sub-group, which tends to be contemporary in style. Finally, the historical style building group is nine buildings (6%). The shape of the facade in each group can be seen in Figure 2. In the historical style group, the buildings have several similar facade elements, such as the shape of the roof and its ornaments. In the contemporary-style building group, these buildings have things in common, such as not having detailed facade elements and tending to use plain materials.

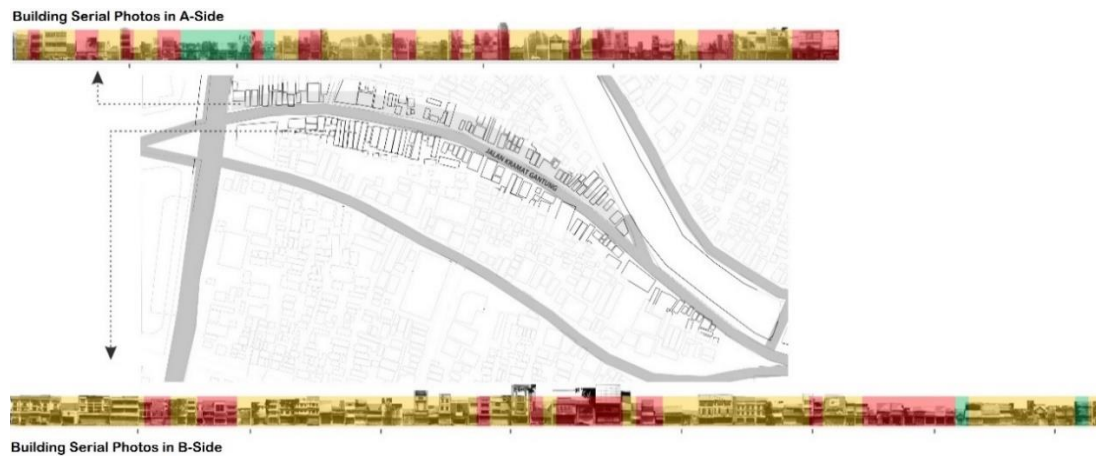
**Figure 3.** Distribution of Building Styles  
*Authors' Analysis*

The distribution of these three groups in Figure 3 shows a complete image of this road corridor. In the figure, several historical-style buildings gather at one point (green colour), then the contemporary style (red colour) spreads out fairly evenly. Thus, the dominance of the transitional style (yellow colour) makes it difficult to describe the physical identity in this area. It can also be concluded that Alun-alun Contong does not have a historical style image or has been badly degraded. From the assessment, it was found that there was a dominance of transitional-style buildings. As seen in Table 3, transitional style buildings have a greater value of 42%, which tends to be contemporary-style, than tends to be in historical style, which is only 18%. Further, a detailed analysis of the elements that led to this trend will be further explained in the next section on historical contextualization.

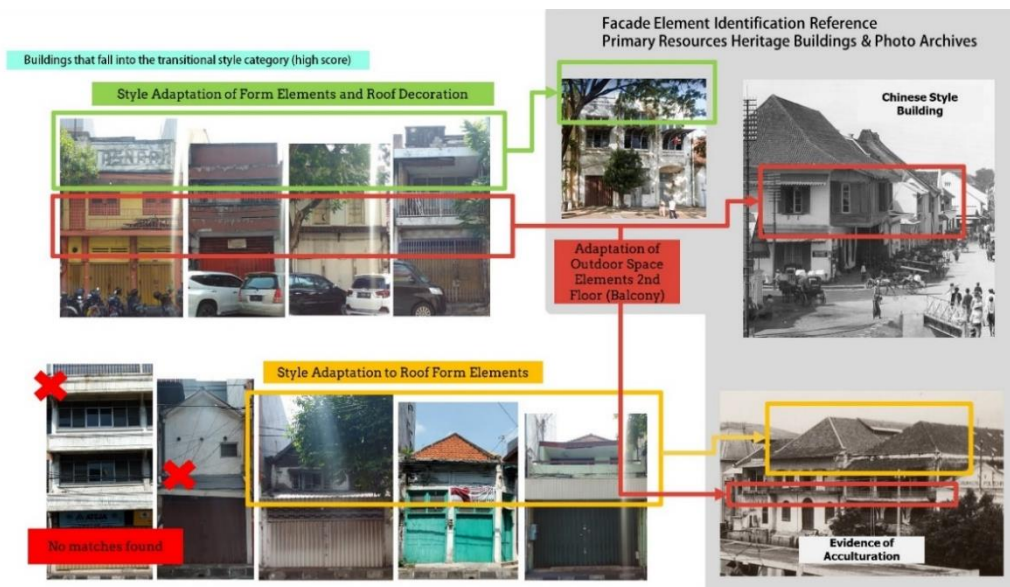
Figure 5. Comparison of Transitional Styles Tend to be Historical in style with Reference Building  
 Authors' analysis

Transitional-style buildings tend to be historical groups that have elements that are similar to the appearance of buildings of historical value. However, some parts are questionable, as shown in Figure 5. First, there is an adaptation of the shape and roof decoration where the roof visibility is hidden and looks flat with ornaments. Second, there is an adaptation of the outer space form (balcony) on the 2nd floor, which is also found in the building archives of acculturation from the Dutch East Indies style and the Chinese style. Meanwhile, the discrepancies are the balcony and roof elements that look flat with a railing on the top side. There are several small circular ventilations on the front side and a concrete canopy under the roof. These facade elements are compatible with the old buildings but are not cultural heritage. Therefore, these elements still have local values but are not the main thing.

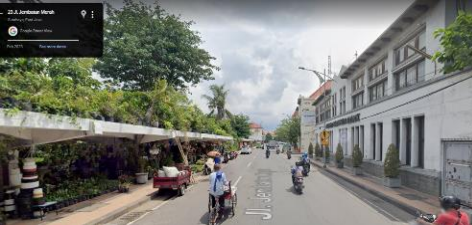
Area	1 <sup>st</sup> Streetview Photo	2 <sup>nd</sup> Streetview Photo
1. Rajawali Street /Initial Surabaya Downtown

<p data-bbox="494 958 769 981">Left Side Building Height: <b>3 m</b></p> <p data-bbox="406 985 845 1041">Ratio: Building Yard-Sidewalk-The Road-Sidewalk-Building Yard</p> <p data-bbox="494 1041 758 1064"><b>0 m – 2 m – 10 m – 2 m – 0 m</b></p> <p data-bbox="494 1064 766 1086">Right Side Building Height: <b>10 m</b></p>

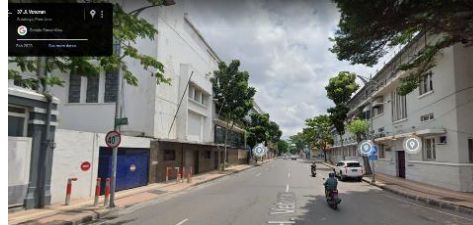
<p data-bbox="981 958 1256 981">Left Side Building Height: <b>± 9 m</b></p> <p data-bbox="893 985 1332 1041">Ratio: Building Yard-Sidewalk-The Road-Sidewalk-Building Yard</p> <p data-bbox="981 1041 1244 1064"><b>0 m – 2 m – 12 m – 2 m – 0 m</b></p> <p data-bbox="981 1064 1260 1086">Right Side Building Height: <b>± 8 m</b></p>
<p><b>The 1<sup>st</sup> area has a wide road space ratio. Historical-style buildings or cultural heritage can be seen clearly. It is possible to drive slowly and pay attention only to buildings to the left or right.</b></p>

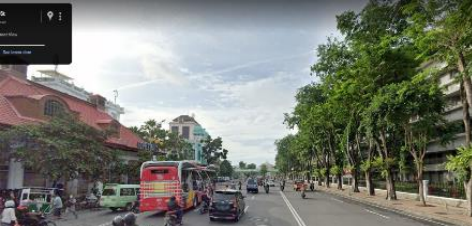
2. Tugu Pahlawan (Hero’s Monument)

<p data-bbox="494 1393 769 1415">Left Side Building Height: <b>± 6 m</b></p> <p data-bbox="406 1420 845 1476">Ratio: Building Yard-Sidewalk-The Road-Sidewalk-Building Yard</p> <p data-bbox="494 1476 758 1498"><b>0 m – 2 m – 30 m – 2 m – 2 m</b></p> <p data-bbox="494 1498 766 1520">Right Side Building Height: <b>± 9 m</b></p>

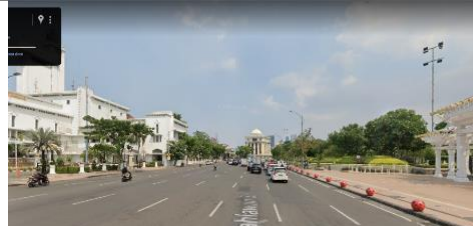
<p data-bbox="981 1393 1256 1415">Left Side Building Height: <b>± 9 m</b></p> <p data-bbox="893 1420 1332 1476">Ratio: Building Yard-Sidewalk-The Road-Sidewalk-Building Yard</p> <p data-bbox="981 1476 1244 1498"><b>25 m – 4 m – 30 m – 8 m – 0 m</b></p> <p data-bbox="981 1498 1260 1520">Right Side Building Height: <b>± 6 m</b></p>
<p><b>The 2<sup>nd</sup> area has a very wide road space ratio. Historical-style buildings or cultural heritage can be seen clearly. It is possible to drive slowly and pay attention to the buildings on the left and right.</b></p>

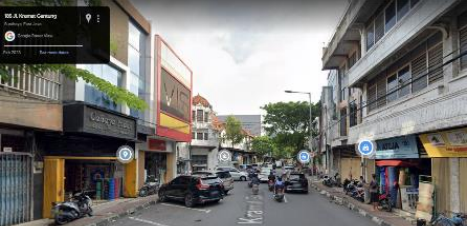
3. Alun-alun Contong

<p data-bbox="494 1859 769 1881">Left Side Building Height: <b>± 12 m</b></p> <p data-bbox="406 1886 845 1942">Ratio: Building Yard-Sidewalk-The Road-Sidewalk-Building Yard</p> <p data-bbox="494 1942 758 1964"><b>0 m – 2 m – 12 m – 2 m – 0 m</b></p> <p data-bbox="494 1964 766 1986">Right Side Building Height: <b>± 12 m</b></p>

The 3<sup>rd</sup> area has a narrow path space ratio. The buildings just seem tall and close. The body of the road is used on one side for car parking. Impossible to drive slowly, and can only take a glance/partial view of buildings to the left or right.

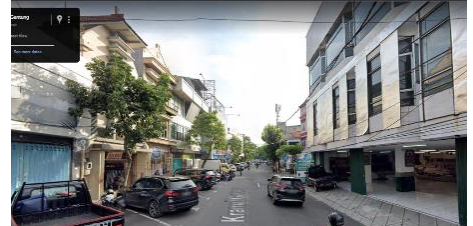
<p data-bbox="981 1859 1256 1881">Left Side Building Height: <b>± 10 m</b></p> <p data-bbox="893 1886 1332 1942">Ratio: Building Yard-Sidewalk-The Road-Sidewalk-Building Yard</p> <p data-bbox="981 1942 1244 1964"><b>0 m – 2 m – 12 m – 2 m – 0 m</b></p> <p data-bbox="981 1964 1260 1986">Right Side Building Height: <b>± 12 m</b></p>

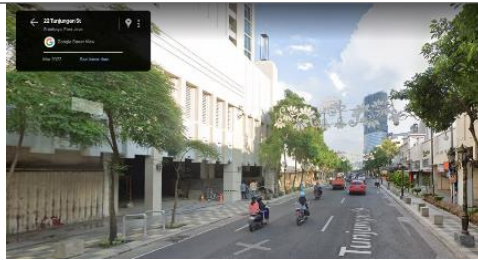
4. Tunjungan Street

Left Side Building Height: ± 12 m  
 Ratio: Building Yard-Sidewalk-The Road-Sidewalk-Building Yard  
 2 m – 2 m – 12 m – 2 m – 2 m  
 Right Side Building Height: ± 6 m

The 4<sup>th</sup> area has a wide road space ratio. Historical-style buildings or cultural heritage can be seen clearly. It is possible to drive slowly and pay attention only to buildings to the left or right.

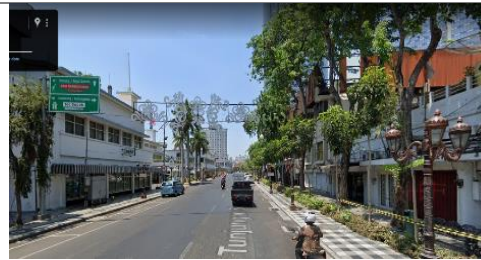
Left Side Building Height: ± 6 m  
 Ratio: Building Yard-Sidewalk-The Road-Sidewalk-Building Yard  
 0 m – 2 m – 12 m – 2 m – 2 m  
 Right Side Building Height: ± 6 m

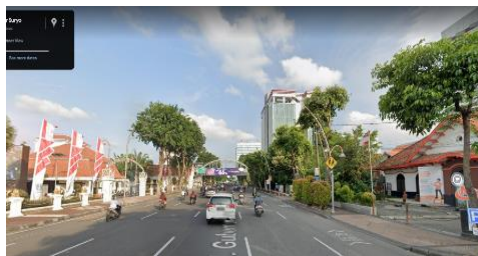
5. Balai Pemuda

Left Side Building Height: ± 9 m  
 Ratio: Building Yard-Sidewalk-The Road-Sidewalk-Building Yard  
 8 m – 3 m – 20 m – 3 m – 12 m  
 Right Side Building Height: ± 8 m

The 5<sup>th</sup> area has a very wide road space ratio. Historical-style buildings or cultural heritage can be seen clearly. It is possible to drive slowly and pay attention to the buildings on the left and right.

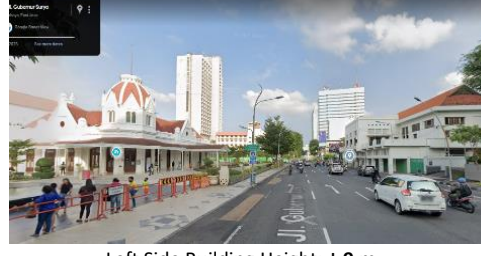
Left Side Building Height: ± 9 m  
 Ratio: Building Yard-Sidewalk-The Road-Sidewalk-Building Yard  
 12 m – 3 m – 20 m – 3 m – 3 m  
 Right Side Building Height: ± 8 m
